**Tree Inventory and Preservation Plan Report  
48 Grenoble Drive  
Toronto, Ontario**

**STUDIO tla  
20 Champlain Boulevard, Suite 102  
Toronto, ON M3H 2Z1**

18 March 2022

KUNTZ FORESTRY CONSULTING INC Project P3112

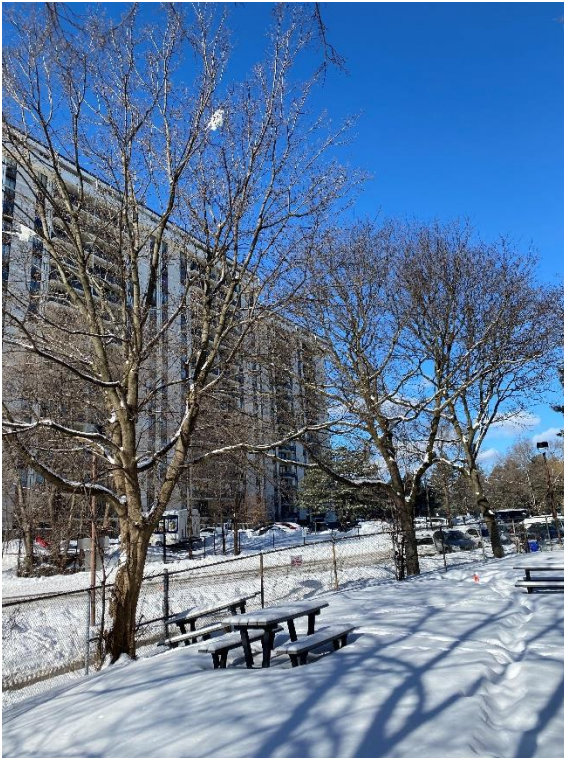
| Tree # | Common Name | Scientific Name | DBH | TI | CS | CV | CDB | mTPZ | Cat. | Comments | Action |
|---|---|---|---|---|---|---|---|---|---|---|---|
| NT778 | Shademaker Honey Locust | <i>Gleditsia triacanthos inermis</i> | 50 | G | G | FG | | 3.6 | 2 | Pruning wounds (L), previously tagged: 080 | Preserve |
| NT779 | Shademaker Honey Locust | <i>Gleditsia triacanthos inermis</i> | 47.5 | FG | G | G | | 3 | 2 | Bow (L), pruning wounds (L), previously tagged: 079 | Preserve |
| 787 | Norway Maple | <i>Acer platanoides</i> | ~52 | PF | FG | G | | 3.6 | 1 | Included fence (M), lean (L), stem wounds (L), v-union at 2m with included bark | Remove |

Image 1. From right (far) to left (near), Trees NT779, NT778, and 787

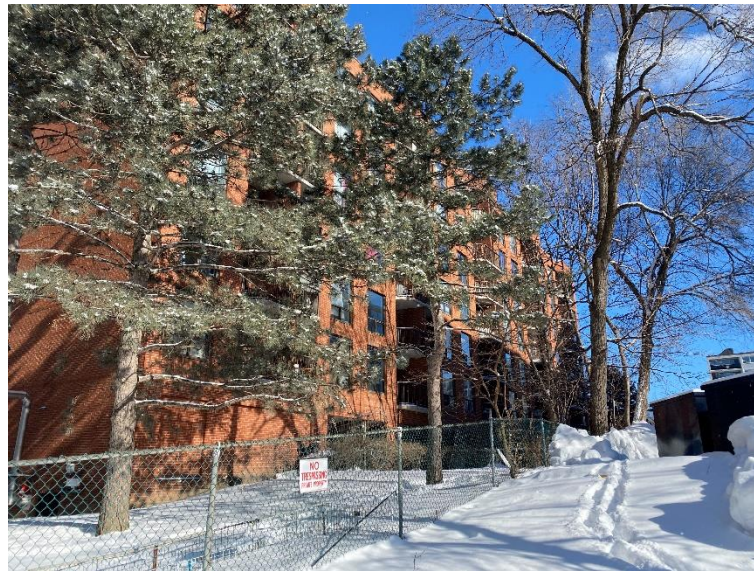
| Tree # | Common Name | Scientific Name | DBH | TI | CS | CV | CDB | mTPZ | Cat. | Comments | Action |
|---|---|---|---|---|---|---|---|---|---|---|---|
| NT780 | Austrian Pine | <i>Pinus nigra</i> | ~32 | FG | G | G | | 2.4 | 2 | Lean (L) | Preserve |
| NT782 | Austrian Pine | <i>Pinus nigra</i> | ~30 | FG | G | G | | 2.4 | 2 | Crook (L) | Preserve |
| 783 | Siberian Elm | <i>Ulmus pumila</i> | 42, 15, 10 | PF | F | G | | 3 | 1 | Included fence (M), lean (L), stem wounds (M) from branch tear-out, pruning wounds (L), union at base | Remove |
| 784 | Norway Maple | <i>Acer platanoides</i> | 15 | FG | FG | FG | | 1.8 | - | Crook (M), poor form (L) | Remove |
| 785 | Siberian Elm | <i>Ulmus pumila</i> | 46 | FG | FG | PF | | 3 | 1 | Lean (L), broken branches (L) | Remove |

Image 2. From left (near) to right (far), Trees NT780, NT782, 785, 784, and 783

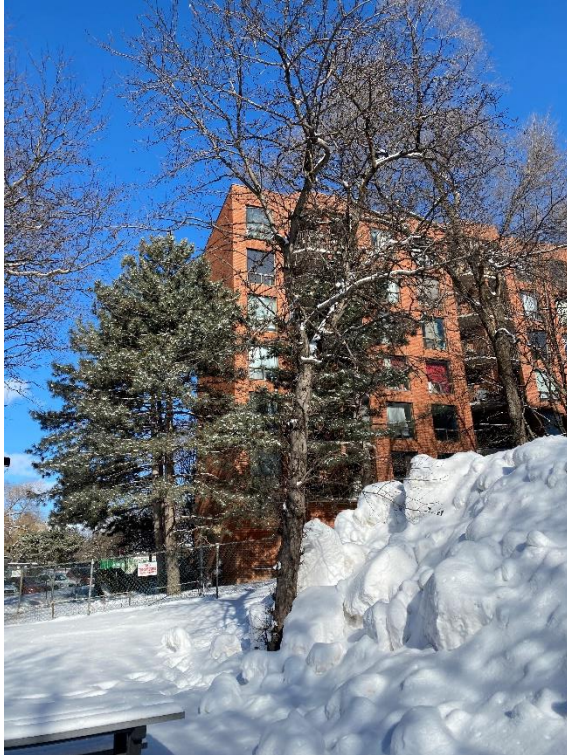
Image 3. Tree 786

| Tree # | Common Name | Scientific Name | DBH | TI | CS | CV | CDB | mTPZ | Cat. | Comments | Action |
|---|---|---|---|---|---|---|---|---|---|---|---|
| 786 | Apple species | <i>Malus sp.</i> | 32 | FG | F | FG | | 2.4 | 1 | One leader cut at 0.2m, epicormic branching (H), lean (L) | Remove |

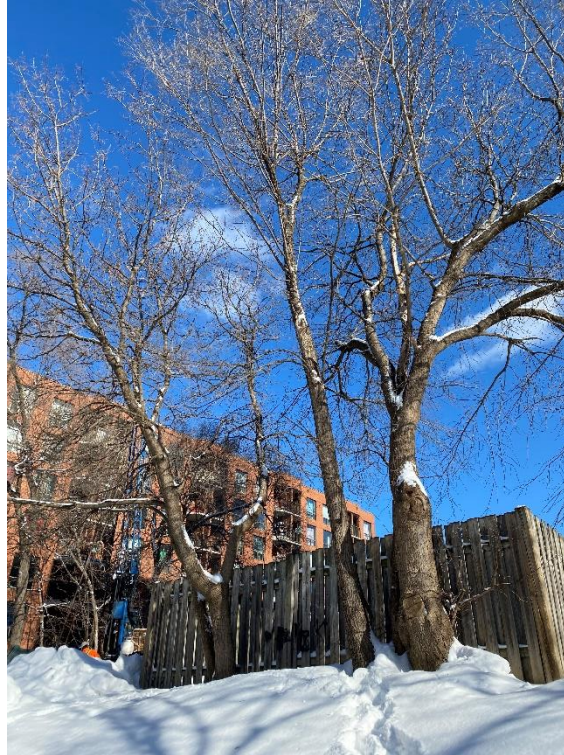
| Tree # | Common Name | Scientific Name | DBH | TI | CS | CV | CDB | mTPZ | Cat. | Comments | Action |
|---|---|---|---|---|---|---|---|---|---|---|---|
| 788 | Manitoba Maple | <i>Acer negundo</i> | 20.5, 26 | F | F | FG | | 1.8 | - | V-union at 0.2m with included bark, crook (L), asymmetrical crown (M) | Remove |
| 789 | Siberian Elm | <i>Ulmus pumila</i> | 26, 17 | FG | FG | PF | 10 | 1.8 | - | Union at base, crook (L), deadwood (L) | Remove |
| 790 | Manitoba Maple | <i>Acer negundo</i> | 40 | FG | F | FG | 15 | 2.4 | 1 | Pruning wounds (M), deadwood (L), broken branches (L), asymmetrical crown (L), crook (L) | Remove |

Image 4. From left to right, Trees 788 – 790

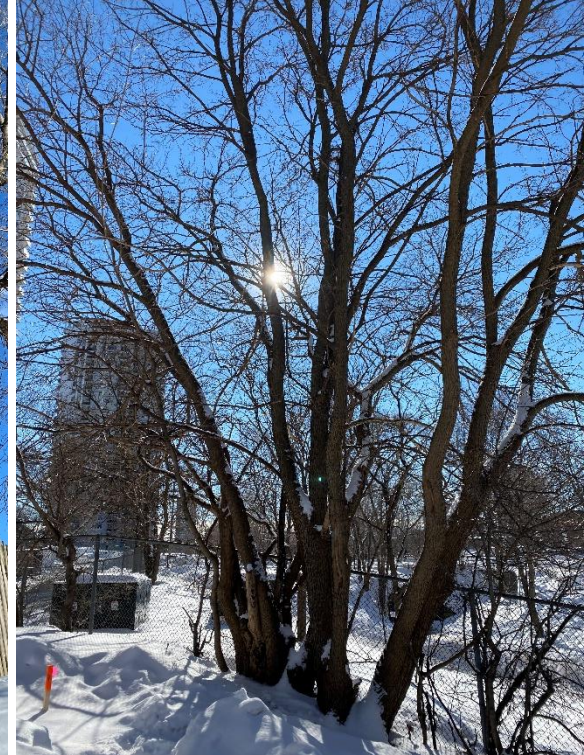
| Tree # | Common Name | Scientific Name | DBH | TI | CS | CV | CDB | mTPZ | Cat. | Comments | Action |
|---|---|---|---|---|---|---|---|---|---|---|---|
| 791 | White Mulberry | <i>Morus alba</i> | 35, 21 | F | FG | FG | | 2.4 | 1 | Lean (L), v-union at 1m with included bark, asymmetrical crown (L), pruning wounds (L), included fence (L) | Remove |
| 792 | White Mulberry | <i>Morus alba</i> | 35, 16 | FG | FG | F | 10 | 2.4 | 1 | V-union at 0.75m with included bark, union at 2m, deadwood (L) | Remove |
| 793 | White Mulberry | <i>Morus alba</i> | ~24, 22, 21, 18 | F | F | F | 15 | 1.8 | - | Union at base with four leaders, asymmetrical crown (M), bow (M), deadwood (L), included fence (L) | Remove |

Image 5. From right to left, Trees 791 – 793

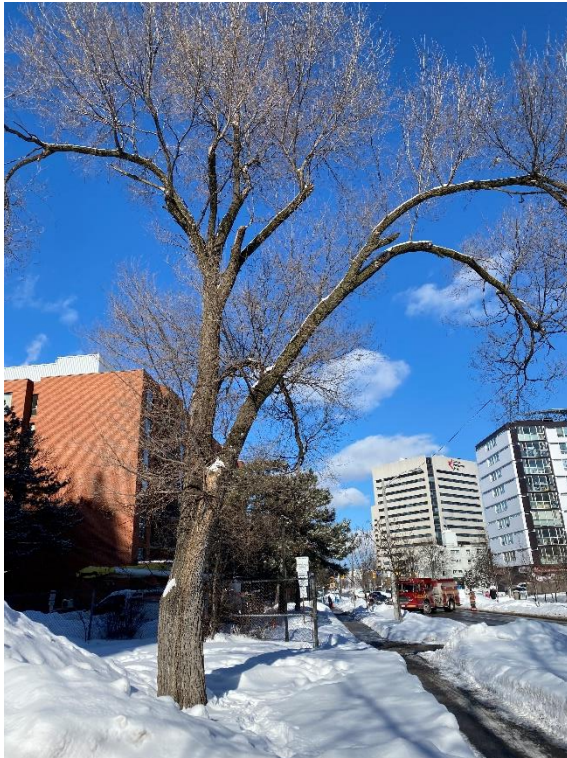
Image 6. Tree 794

| Tree # | Common Name | Scientific Name | DBH | TI | CS | CV | CDB | mTPZ | Cat. | Comments | Action |
|---|---|---|---|---|---|---|---|---|---|---|---|
| 794 | Siberian Elm | <i>Ulmus pumila</i> | 62 | F | FG | FG | | 4.2 | 1 | V-union at 1.5m with included bark, broken branches (L), pruning wounds (L), bow (L) | Remove |

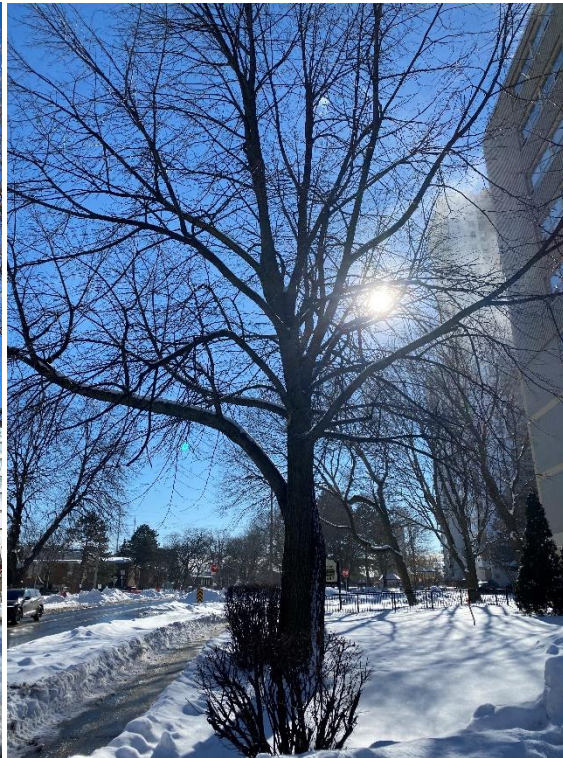
Image 7. Tree 795

| Tree # | Common Name | Scientific Name | DBH | TI | CS | CV | CDB | mTPZ | Cat. | Comments | Action |
|---|---|---|---|---|---|---|---|---|---|---|---|
| 795 | Siberian Elm | <i>Ulmus pumila</i> | 50, 42, 37 | F | FG | FG | | 3 | 1 | V-unions at base and 0.1m, bow (L) | Remove |

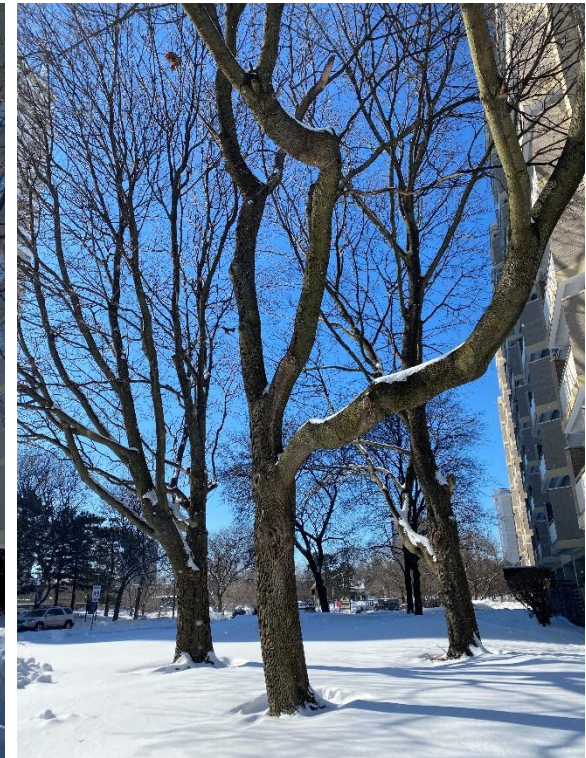
| Tree # | Common Name | Scientific Name | DBH | TI | CS | CV | CDB | mTPZ | Cat. | Comments | Action |
|---|---|---|---|---|---|---|---|---|---|---|---|
| 796 | Norway Maple | <i>Acer platanoides</i> | 51 | F | FG | F | 10 | 3.6 | 1 | Lean (M), broken branches (L), deadwood (L), stem wounds (L) with decay (L) | Remove |
| 797 | Norway Maple | <i>Acer platanoides</i> | 63 | FG | FG | F | 10 | 4.2 | 1 | Pruning wounds (L), deadwood (L), broken branches (L), asymmetrical crown (L), lean (L) | Remove |
| 798 | Norway Maple | <i>Acer platanoides</i> | 69 | PF | FG | F | 10 | 4.2 | 1 | Decay (M) in trunk from base to 2m, v-union at 2m with included bark, asymmetrical crown (L), pruning wounds (L), deadwood (L) | Remove |

Image 8. From left to right, Trees 798, 796, and 797

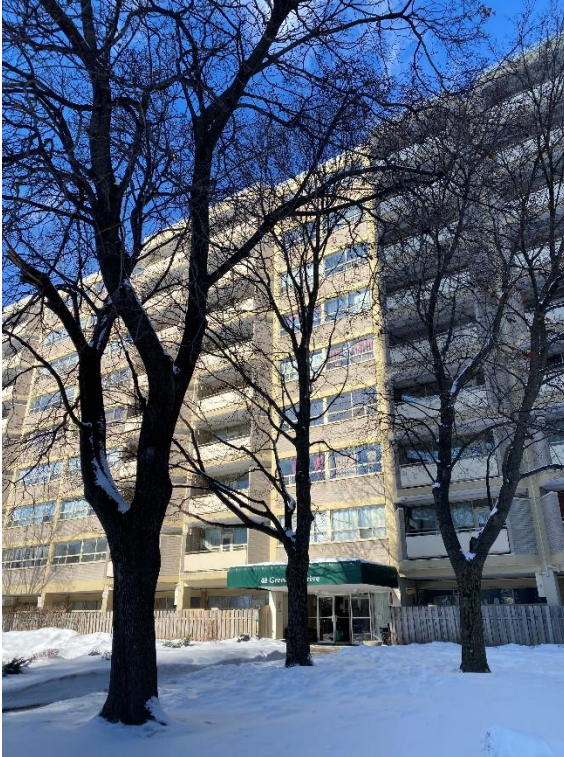
| Tree # | Common Name | Scientific Name | DBH | TI | CS | CV | CDB | mTPZ | Cat. | Comments | Action |
|---|---|---|---|---|---|---|---|---|---|---|---|
| 799 | Norway Maple | <i>Acer platanoides</i> | 51 | FG | FG | FG | | 3.6 | 1 | Union at 2.5m (codominance), asymmetrical crown (L), pruning wounds (L), crook (L) | Remove |
| 800 | Norway Maple | <i>Acer platanoides</i> | 49 | G | FG | F | 10 | 3 | 1 | Asymmetrical crown (L), deadwood (L), pruning wounds (L) | Remove |

| 1491 | Norway Maple | <i>Acer platanoides</i> | 67.5 | PF | FG | F | 10 | 4.2 | 1 | Deadwood (L), broken branches (L), pruning wounds (L) with decay (L), lean (L), crook (L), growth deficit (L) | Remove |

Image 9. From right to left, Trees 799, 800, and 1491

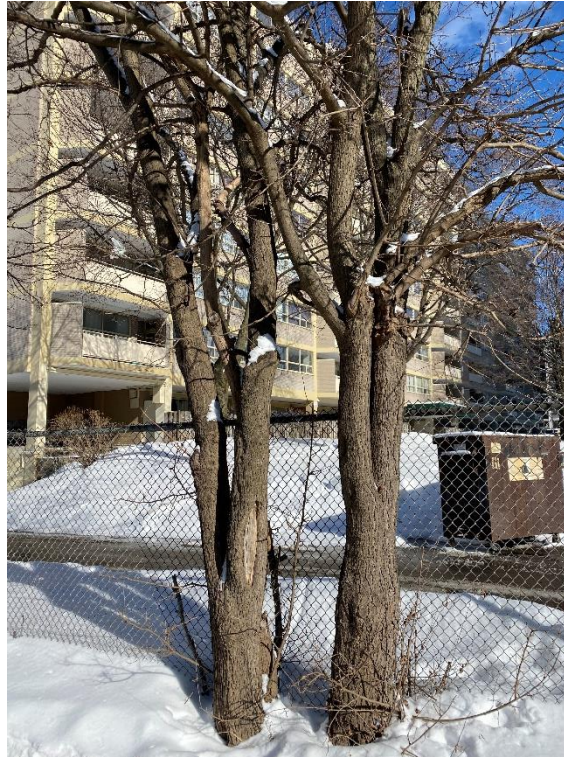
| NT1494 | White Mulberry | <i>Morus alba</i> | ~20, 19 | F | F | F | 10 | 1.8 | - | V-union at 0.5m with included bark with leaders fused to 1.5m, pruning wounds (L), epicormic branching (L), deadwood (L), included fence (L) | Remove |
| NT1495 | White Mulberry | <i>Morus alba</i> | 19, 18 | F | FG | F | 25 | 1.8 | - | Stem wounds (M) with decay (L), deadwood (M), v-union at 0.5m with included bark, pruning wounds (L), included fence (L) | Remove |

Image 10. Trees NT1494 (right) and NT1495 (left)

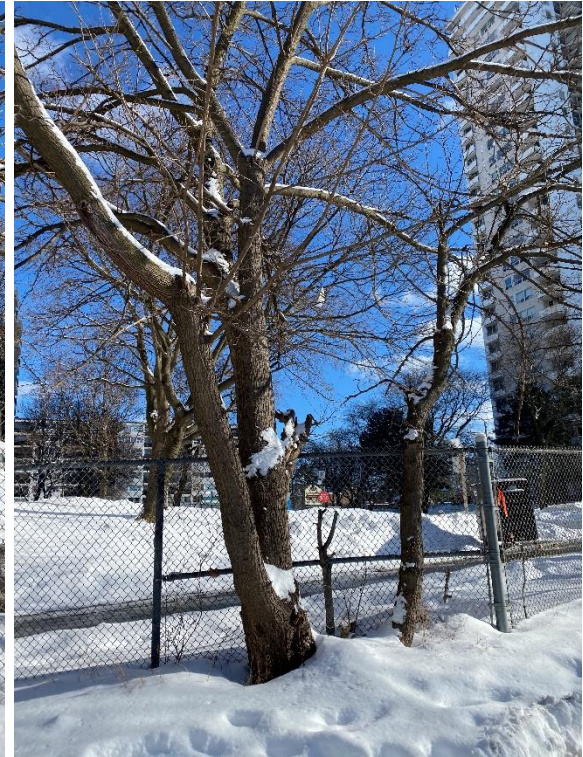
| NT1496 | White Mulberry | <i>Morus alba</i> | ~19 | F | F | F | 10 | 1.8 | - | Sweep (L), included fence (L), asymmetrical crown (L), deadwood (L) | Remove |
| NT1497 | White Mulberry | <i>Morus alba</i> | ~36, 20 | F | FG | F | 10 | 2.4 | 1 / 2 | Deadwood (L), union at 0.5m, pruning wounds (L), included fence (L), v-union at 2.5m with included bark and decay (L) | Remove |

Image 11. Trees NT1496 (right) and NT1497 (left)
